SAN NICOLAS ISLAND BARGE LANDING SITE SURVEY

FPO-1-79(3)
NOVEMBER 1978

OCEAN ENGINEERING AND CONSTRUCTION PROJECT OFFICE
CHESAPEAKE DIVISION
NAVAL FACILITIES ENGINEERING COMMAND
WASHINGTON, D.C. 20374

Pacific Missile Test Center
Point Mugu, California

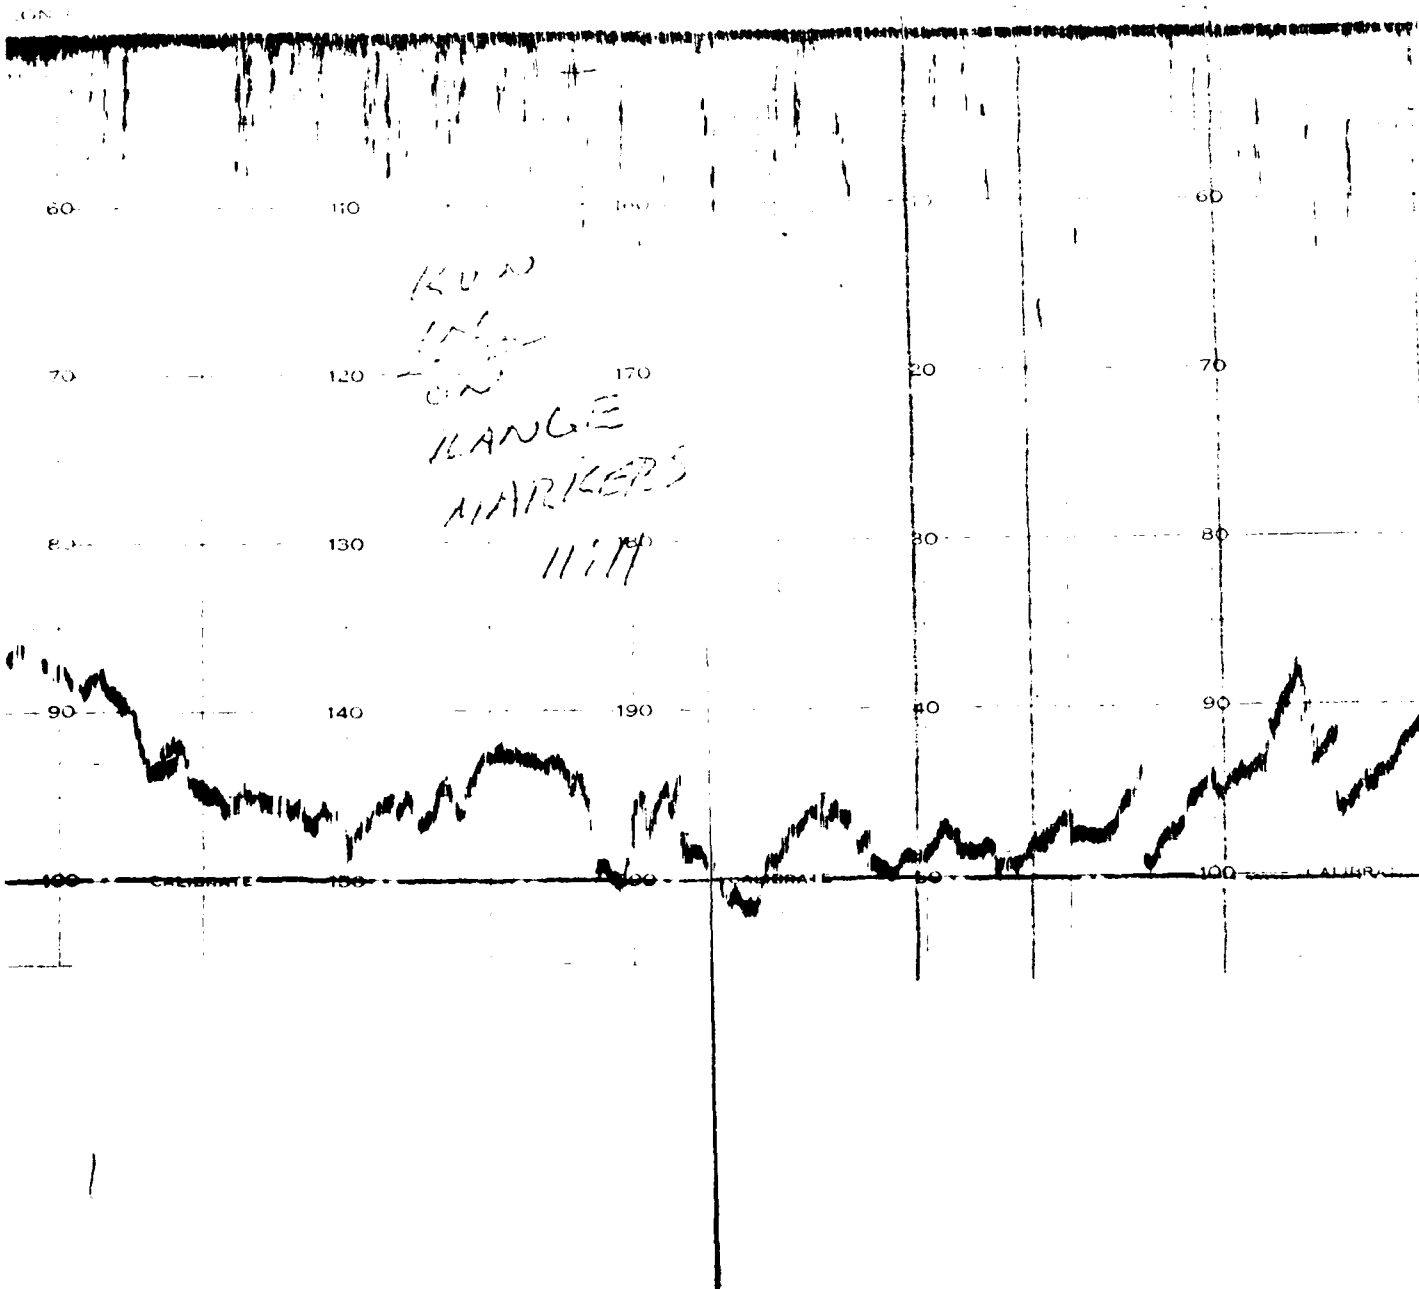
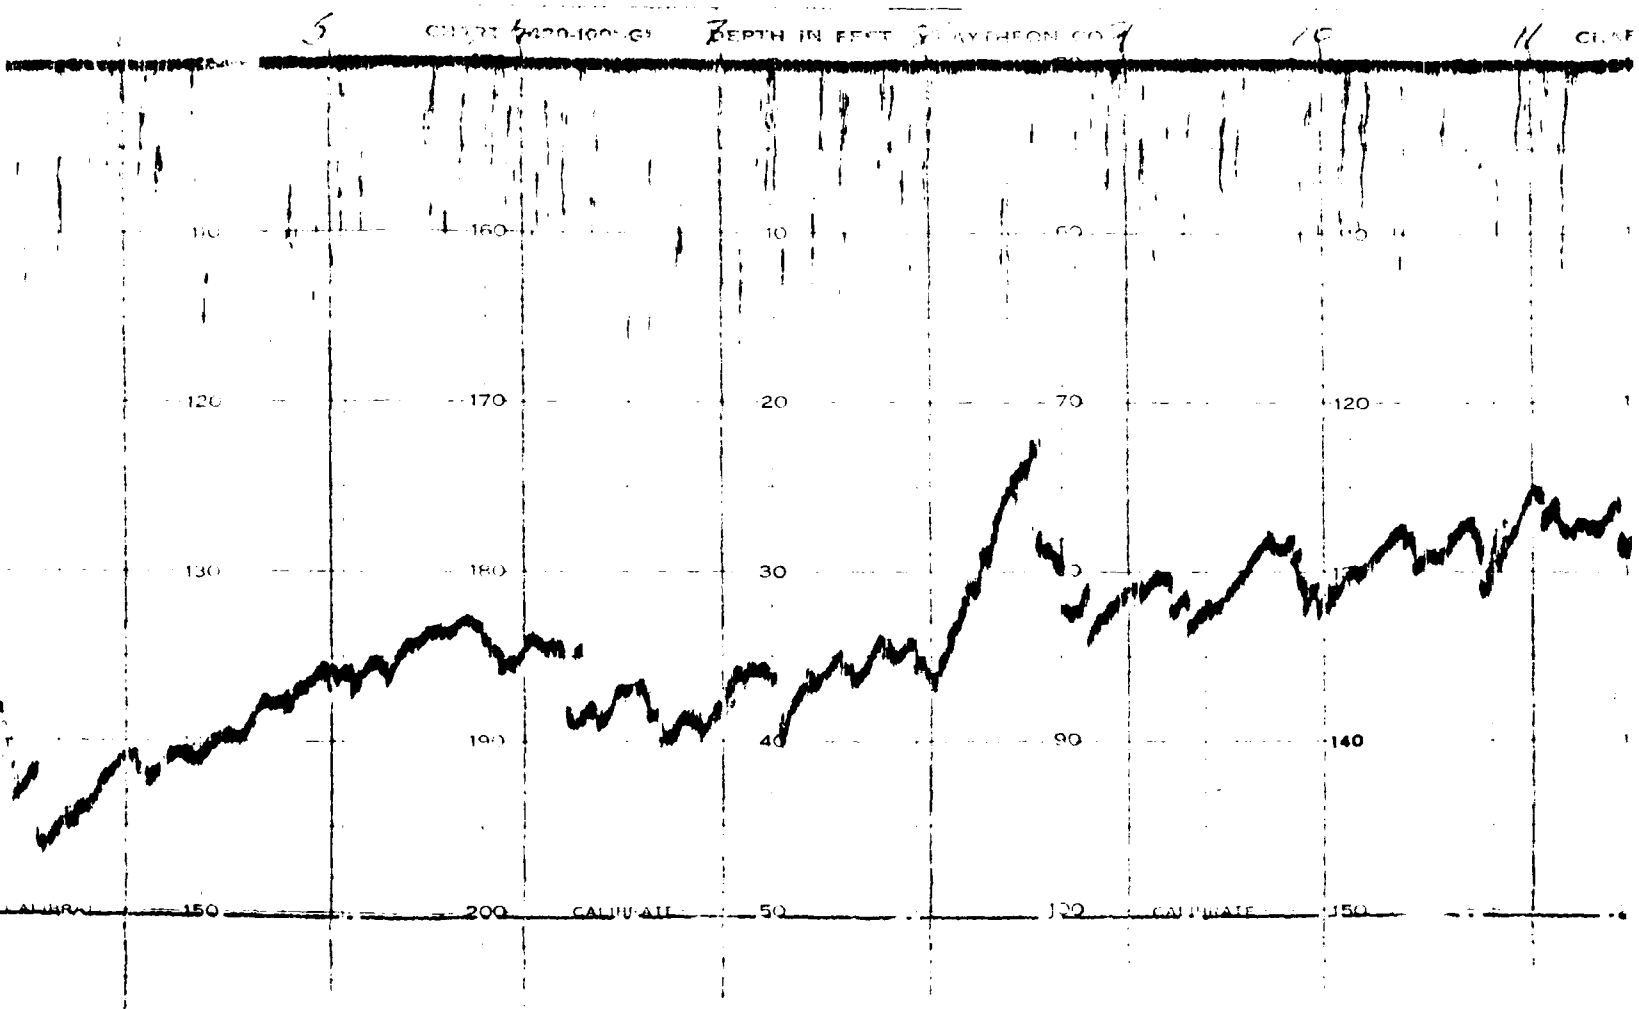
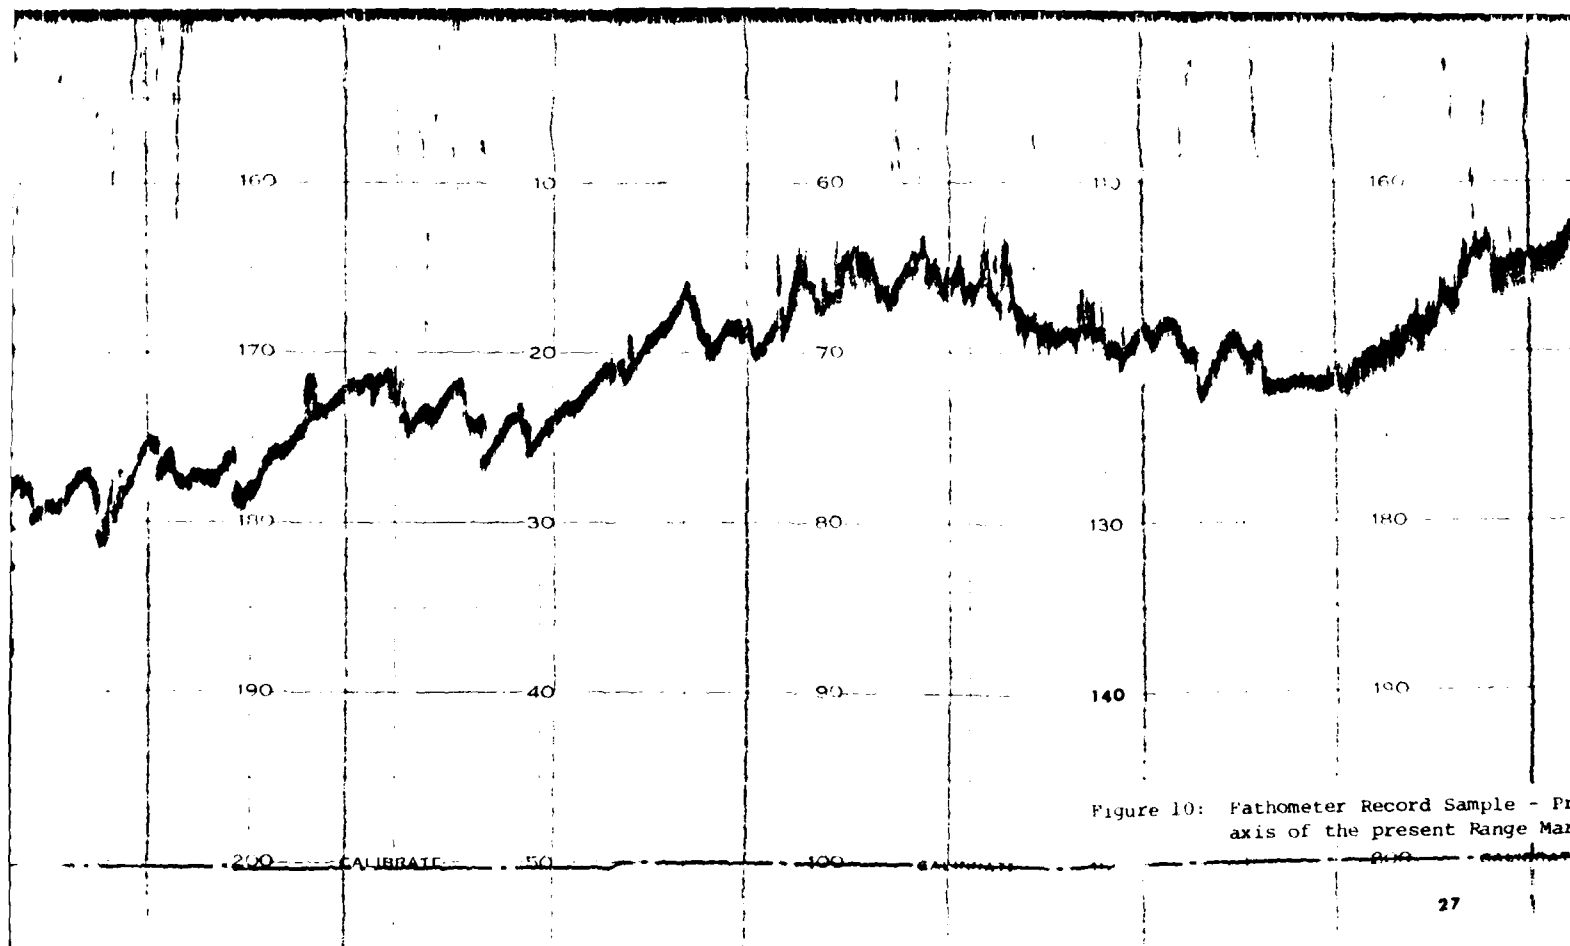
Figure 10: Fathometer Record Sample - Pr
axis of the present Range Mar

Figure 10: A run into the beach from the sea using the present range markers as the navigation control for the LARC-5. The tidal level during the run was 5 feet above MLLW. Note that no obstructions would interfere with the YFU transit (7 foot draft) over this exact alignment at high tide.
